Title: Bi2Te3 Wafers Inspection Update

Progress update: October 11, 2018

Bi₂Te₃ Wafers Inspection Update

Develop a fast and efficient technique to detect cracked wafers via combination of machine learning, optics, and ultrasound

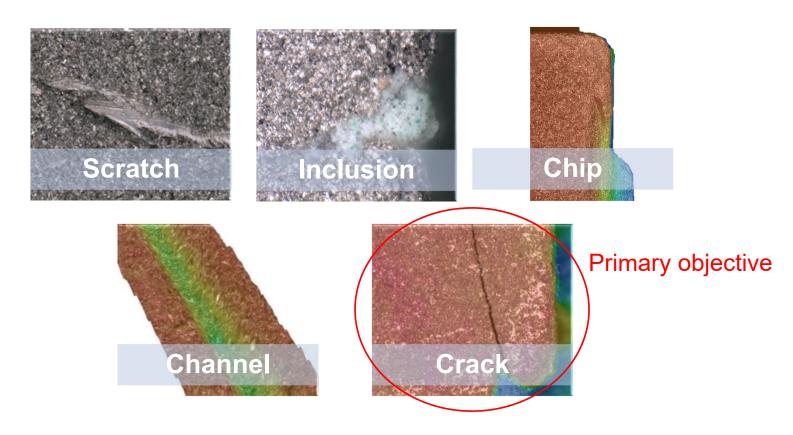
Wafer Defect types

A number of different defect types have been identified:

Can we identify flaws that could grow to be cracks during processing or service?

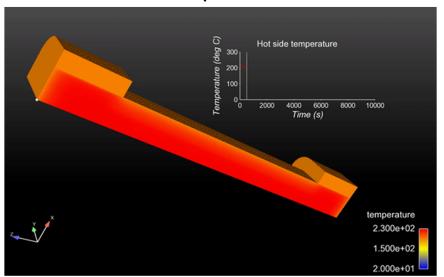
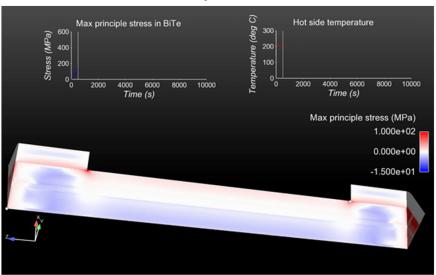
3D Models Determine Maximum Tensile Stress During Cool Down After TEPOX Epoxy Curing

Temperature

Principal Stress

Current best estimates of the maximum principal stress, $\sigma_c \approx$ 50 MPa

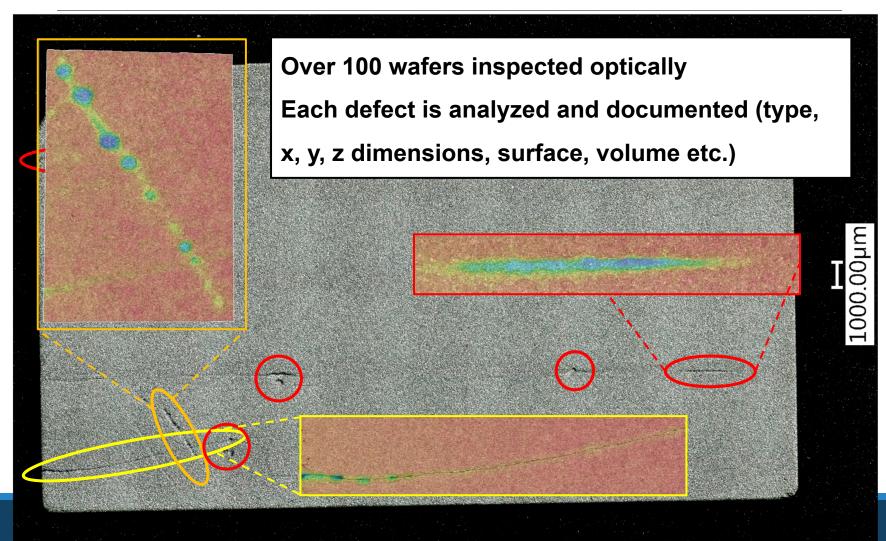
Keyance VHX 6000

Optical measurement of wafer defects

Microscopy allows us to gather information on individual wafers

The constitution of a library of defects is indispensable to better understand the materials characteristics. We are attempting to correlate it to the acoustics data.

Over 100 wafers inspected optically Over 400 individual defects reported Cracks: 128 Chips: 63 Channels: 442

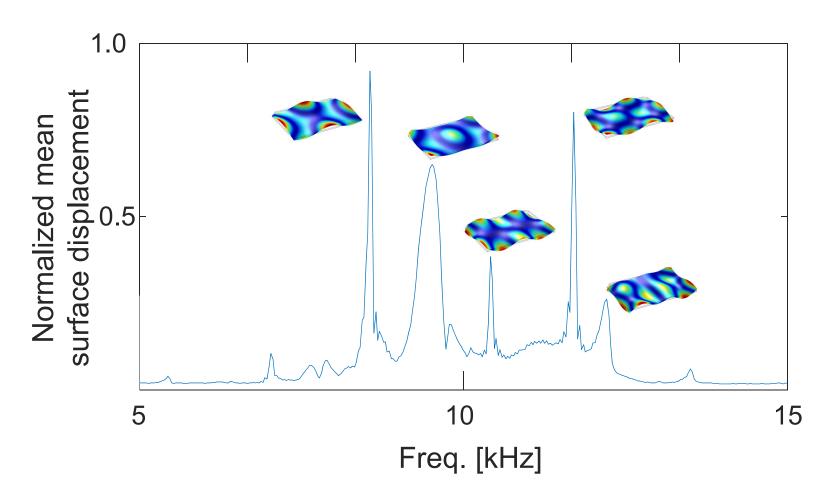
Acoustic Resonance Spectroscopy (ARS)

Wafer vibrational modes result in a peak in the mean surface displacement

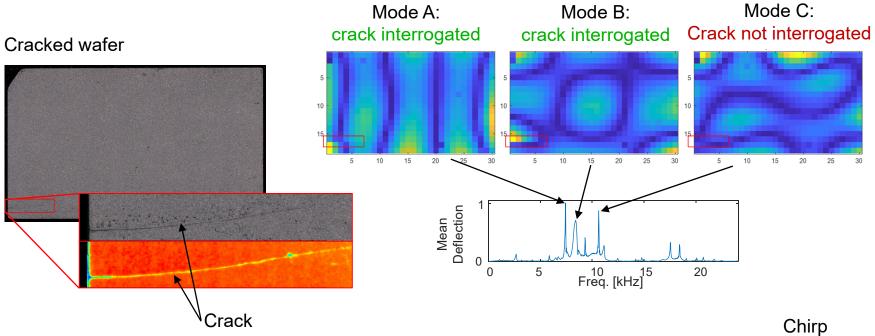
Effect of Crack Location

Crack excitation amplified when crack coincides with resonant mode maxima

We must excite multiple modes to ensure crack interrogation
We select a chirp from 8 kHz to 12 kHz to excite ~3 wafer modes

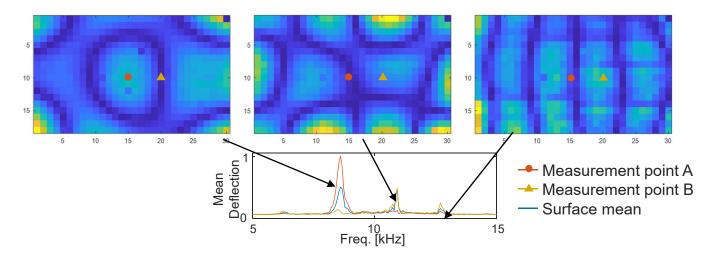
Effect of Measurement Location

Measured signal dependent on measurement location

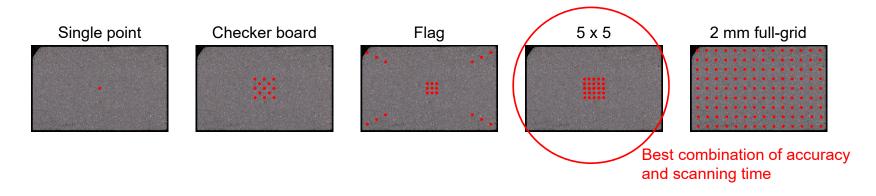
We measure a multi-point scanning pattern across the wafer surface

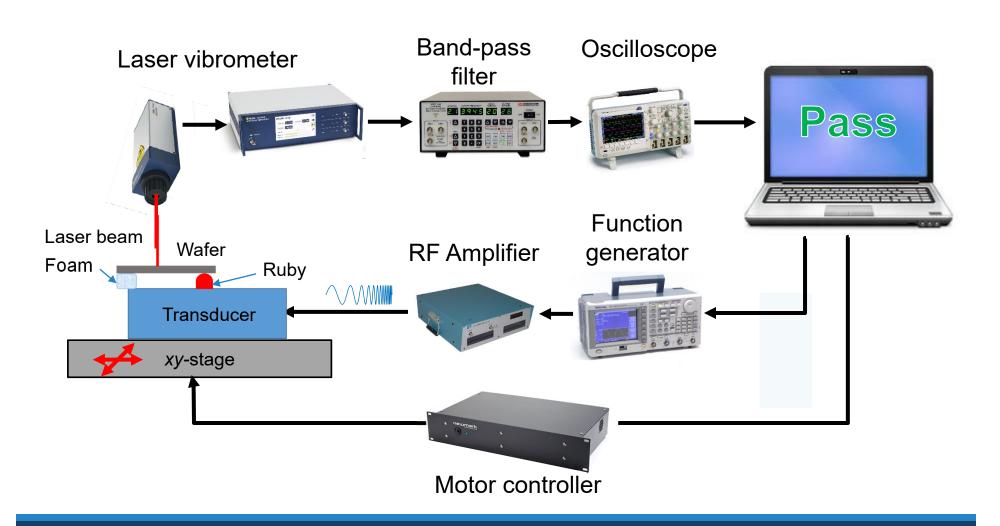
Experimental Setup

Measurement process controlled via a single PC

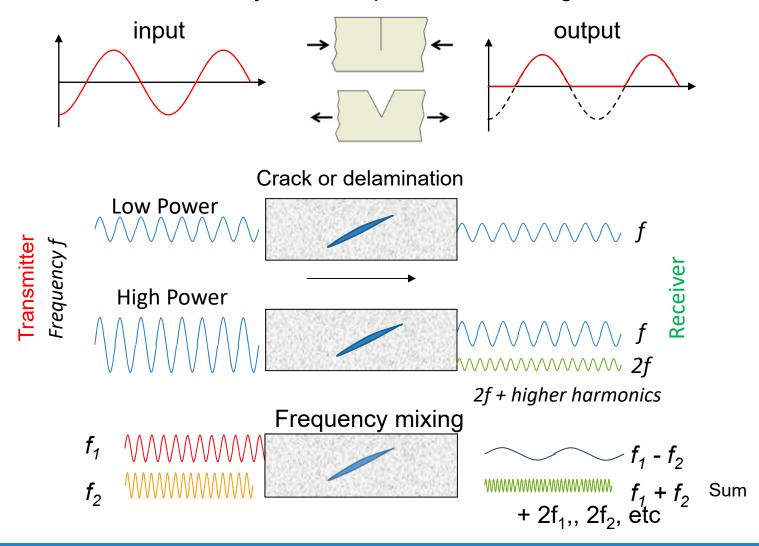
Acoustic Nonlinearity

Contact acoustic nonlinearity: Cracks open/close resulting in nonlinearities

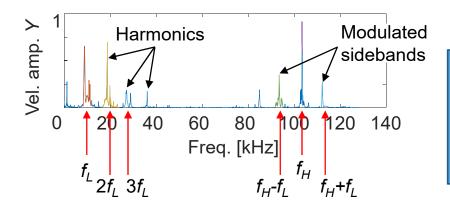
Acoustic Nonlinearity (2)

We input a low-frequency, sweeping "Pump" signal and high-frequency, fixed "Probe" signal

This will result in nonlinear harmonics and modulated sidebands

Nonlinearity metrics:

Harmonics:
$$M_{harm} = \frac{\|Y_{2L} + Y_{3L}\|}{\|Y_L\|}$$

Modulated sidebands: $M_{mod} = \frac{\|Y_{H+L} + Y_{H-L}\|}{\max Y}$

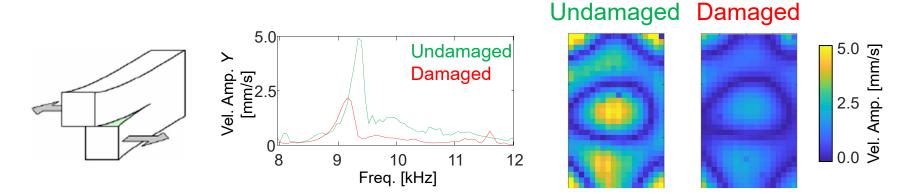
Mean amplitude

Friction between crack faces absorbs energy and reduces the resonance amplitude

Mean resonance amplitude is quantified as

Mean amplitude:
$$M_{amp} = \frac{1}{N} \sum_{i=1}^{N} Y_i$$

High mean amplitude implies an undamaged wafer Low mean amplitude implies a damaged wafer

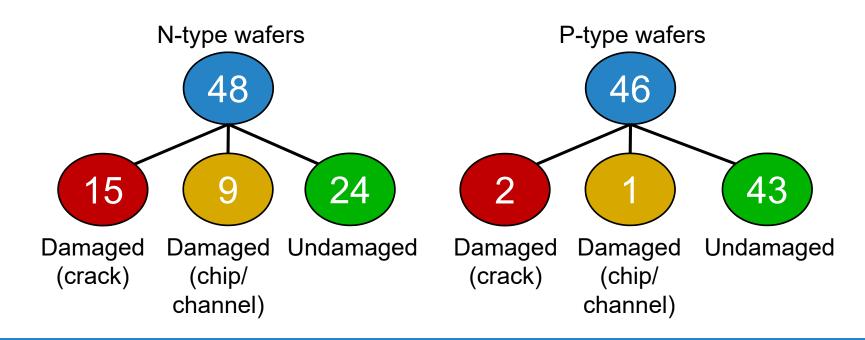
Statistical trial of wafers (Optical measurement)

Keyance VHX 6000

- We characterize wafers defects optically
- Wafers with defect depths >110 µm are characterized as "damaged" and defect depths <110 µm are characterized as "undamaged"

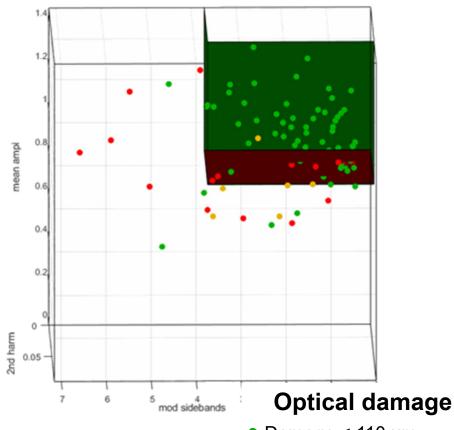
Statistical trial of wafers (Acoustic measurement)

Acoustic damage classification using:

- 2nd harmonic
- Modulated sidebands
- Mean amplitude

Inside box: undamaged Outside box: damaged

- 17/17 cracked wafers FAIL
- 6/10 chip/channel wafers FAIL
- 56/67 undamaged wafers PASS

- Damage < 110 µm
- Chip/channel > 110 μm
- Crack > 110 μm

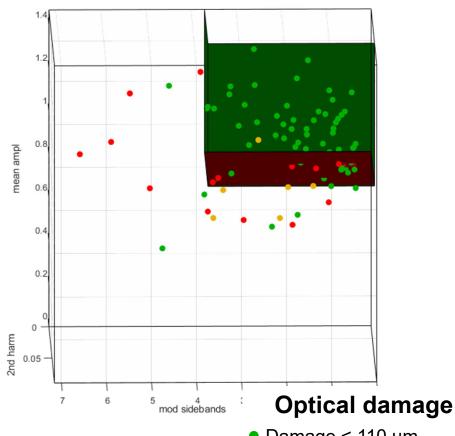
Statistical trial of wafers (Acoustic measurement)

Acoustic damage classification using:

- 2nd harmonic
- Modulated sidebands
- Mean amplitude

Inside box: undamaged Outside box: damaged

- 17/17 cracked wafers FAIL
- 6/10 chip/channel wafers FAIL
- 56/67 undamaged wafers PASS

- Damage < 110 µm
- Chip/channel > 110 µm
- Crack > 110 µm

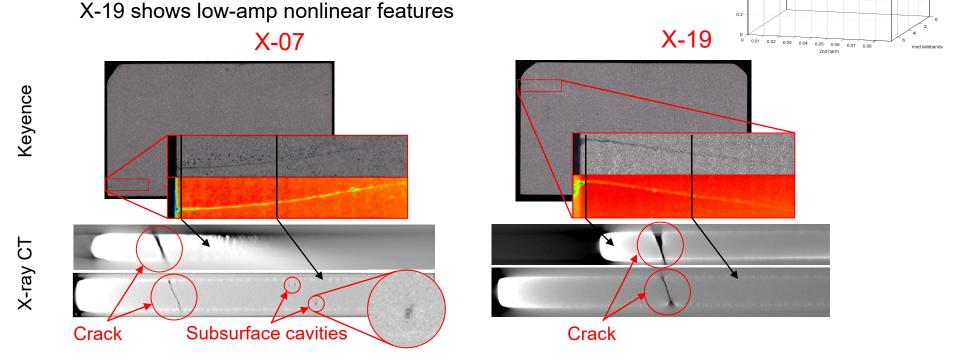
Comparison of damage measurement techniques (2)

Why do some cracks result in higher nonlinear acoustic effects?

E.g. X-07 shows high-amp nonlinear features, but

- X-19 cracks are wider and inhibit crack "breathing," which inhibits acoustic nonlinearities
- Additionally, we observe subsurface cavities in X-07, which implies that there can be defects that are not observable optically
 - Thus, some false positives may contain subsurface defects

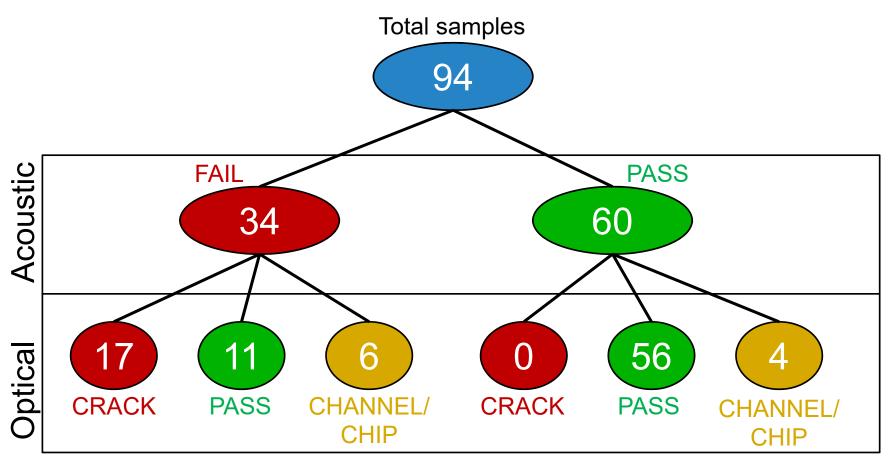
Bottom line

- We correctly classify cracks with
- We correctly classify channels/chips with
- We correctly classify undamaged wafers with 11.7 % total error
- 0.0 % total error
- 4.3 % total error

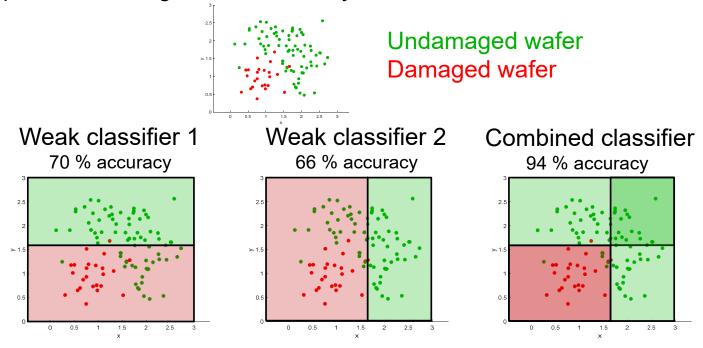
Machine learning damage classification: adaBoost

Creates a strong classifier to identify damaged/undamaged wafers by combining multiple weak classifiers

Example: Two damage metrics x and y

Result: Combining multiple low-accuracy thresholds yields high-accuracy classification

We can add weights to reduce false positives, while increasing false negatives
